Home Inspection Report

Property address: 321 Elm St.
Charleston SC 29414

Inspected by: Stephen Houmar
South Carolina License #2046
Solid Ground Home Inspections, LLC
843.330.2860
Professional Member:
-American Society of Home Inspectors (ASHI)

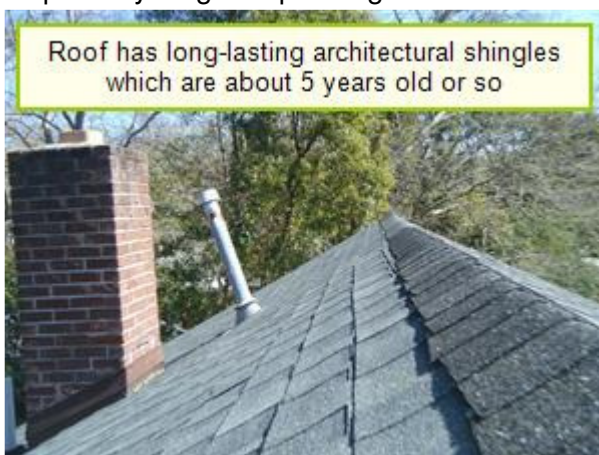
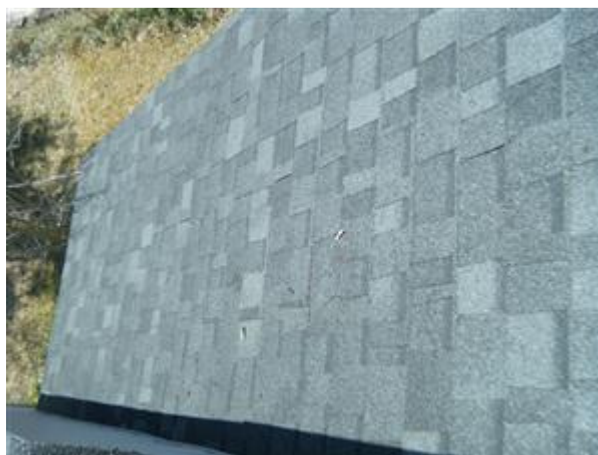
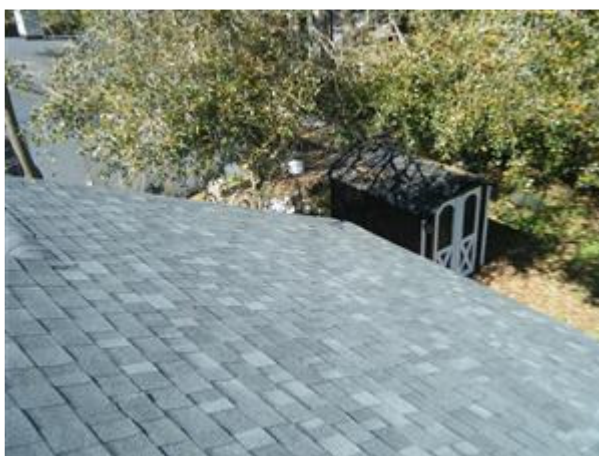
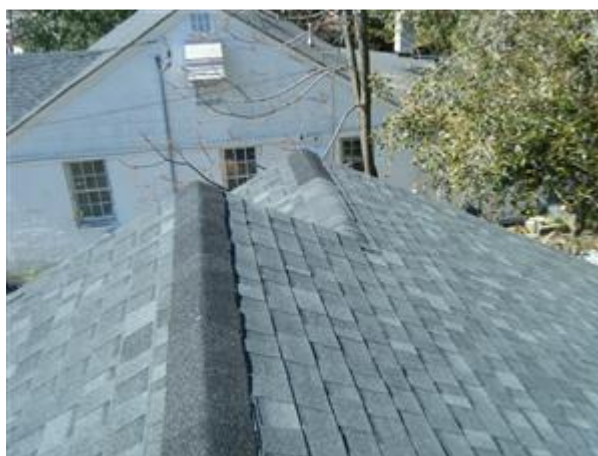
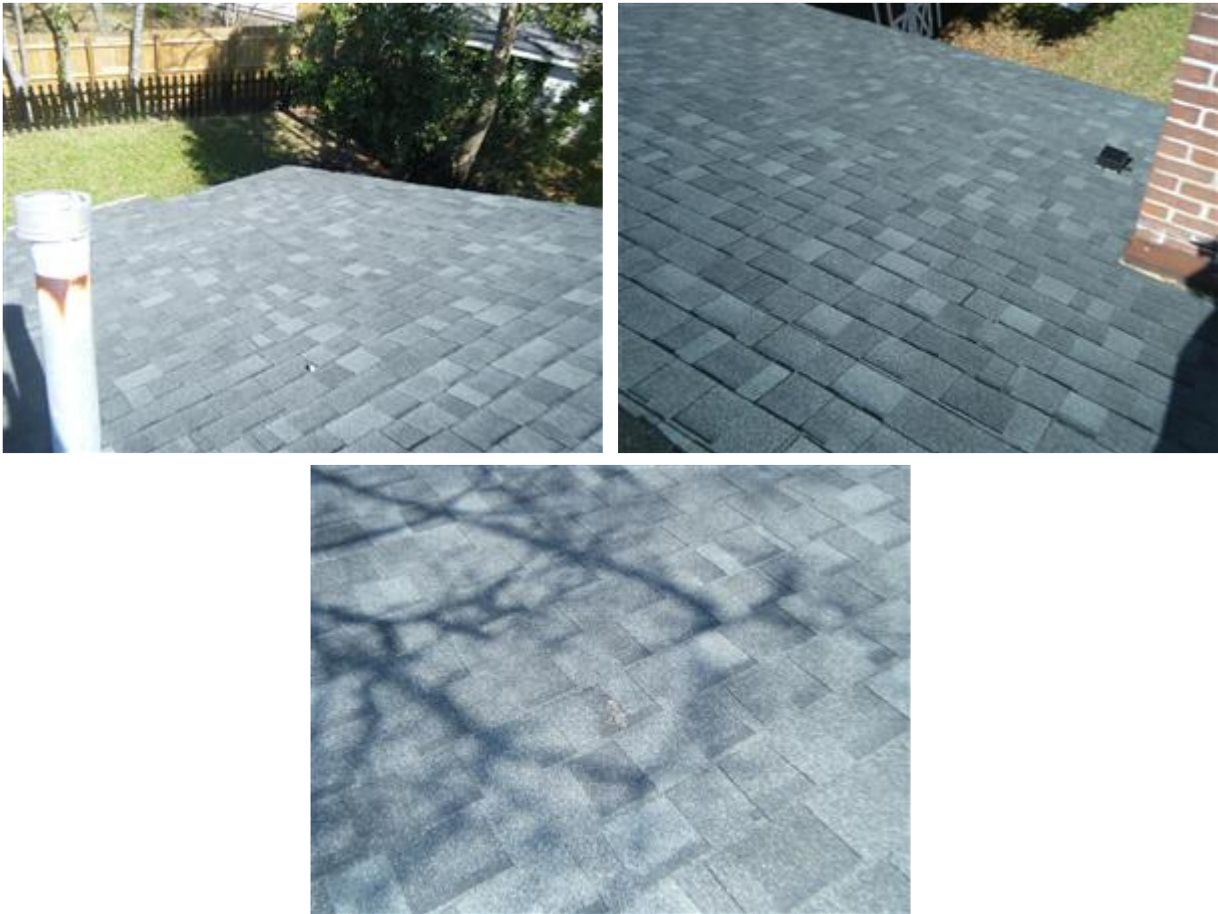
Observed that this home has architectural shingles which are estimated to be 5 years old. For your reference, the average roof with this type of shingles can last up to 35 years and possibly longer depending on the local climate and roof ventilation.

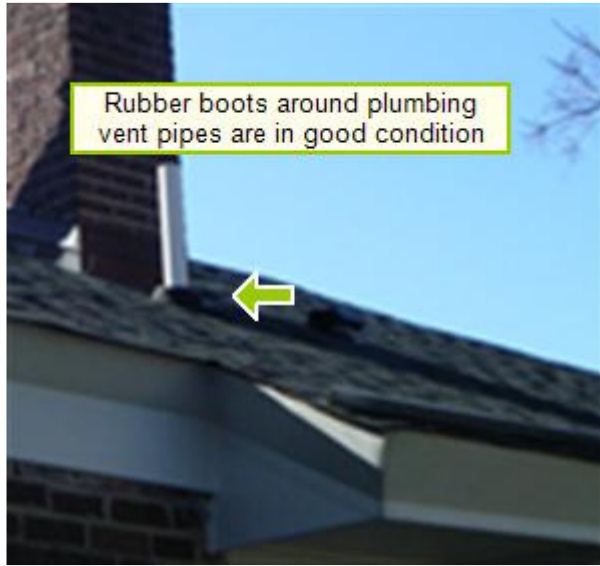
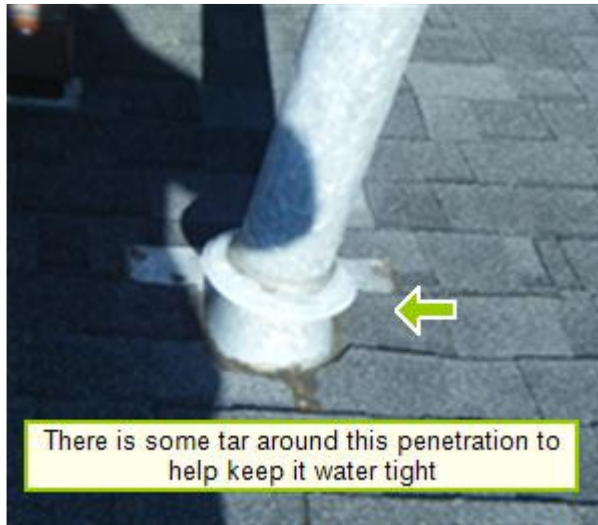
Observed that the flashings are in good condition. For your reference, flashing is a sheet of metal or Neoprene which is installed around pipes and chimneys traveling through the roof to ensure these areas are water tight. Also, flashing is applied along the sidewalls where different parts of the roof come together as well.

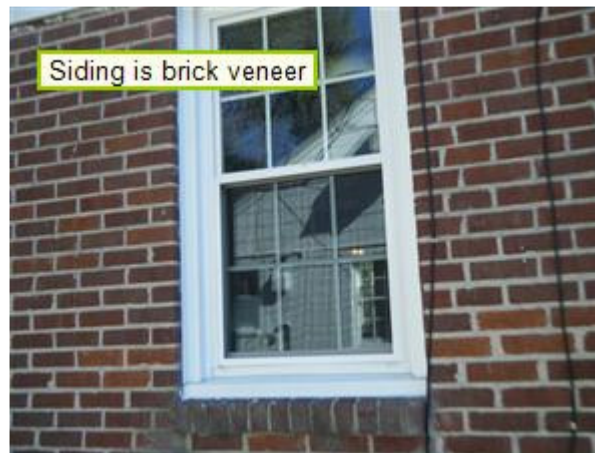
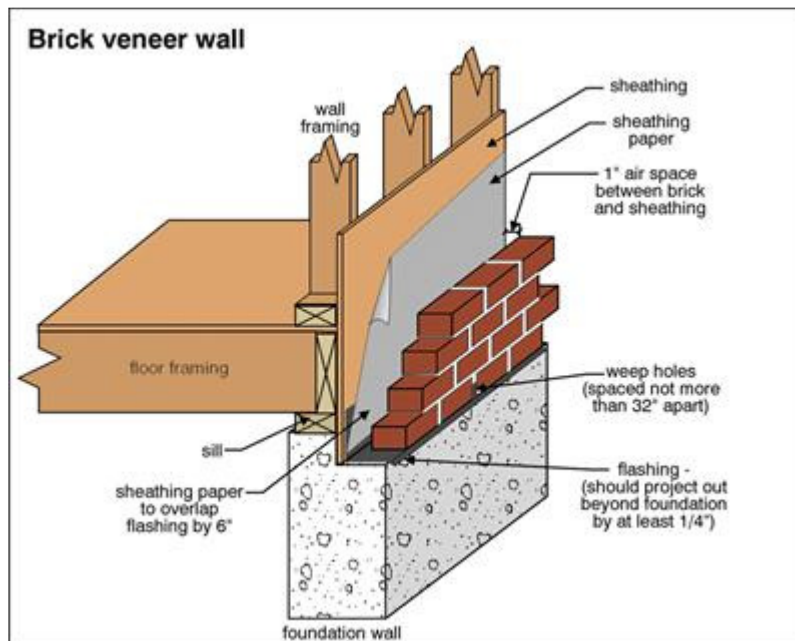
(1) Observed that this home has brick veneer siding. For your reference, most brick houses built in the last 30 years were constructed with brick veneer. The biggest difference between brick veneer and solid masonry is that with solid masonry, the brick is holding up the house. With brick veneer, the house is holding up the brick. The term 'brick veneer' doesn't mean those little thin slices that you glue on your kitchen wall -- it is actually brick. However, the wall is only one wythe thick. Behind the brick veneer is a wood frame wall which is actually holding up the house. Therefore, the brick veneer is really functioning as siding.

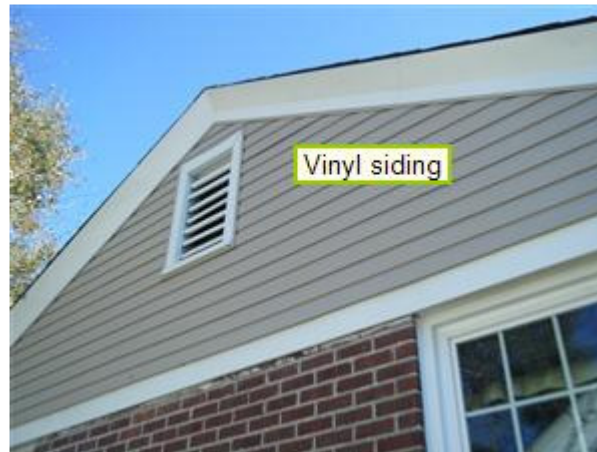
(2) Observed that this home also has some vinyl siding. For your reference, vinyl siding was first introduced to the exterior cladding (siding) market in the early 1960s and steadily grew in popularity over the next four decades because of its durability, versatility and ease of maintenance. Today, vinyl siding is the number one choice of siding across the country. U.S. Census Bureau statistics show twice as many homeowners side their homes with vinyl than with any other material. The product is manufactured primarily with polyvinyl chloride, a material that gives it impact resistance, rigidity and strength. Additionally, you never need to repaint, because the color will not blister, flake or peel and vinyl is not susceptible to moisture buildup, rotting or termite infestation.

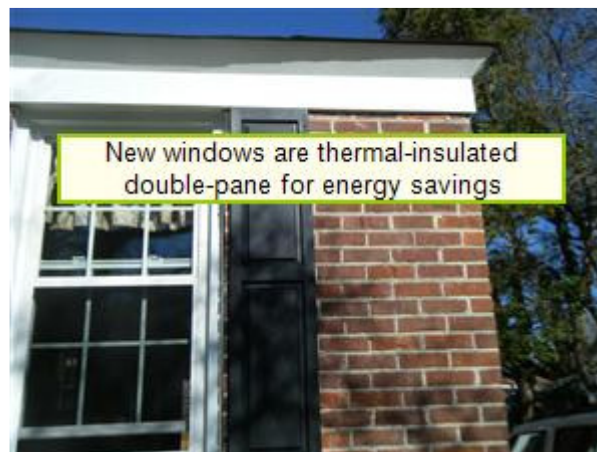
Observed that this home has new thermal-insulated double-pane windows for extra energy savings.

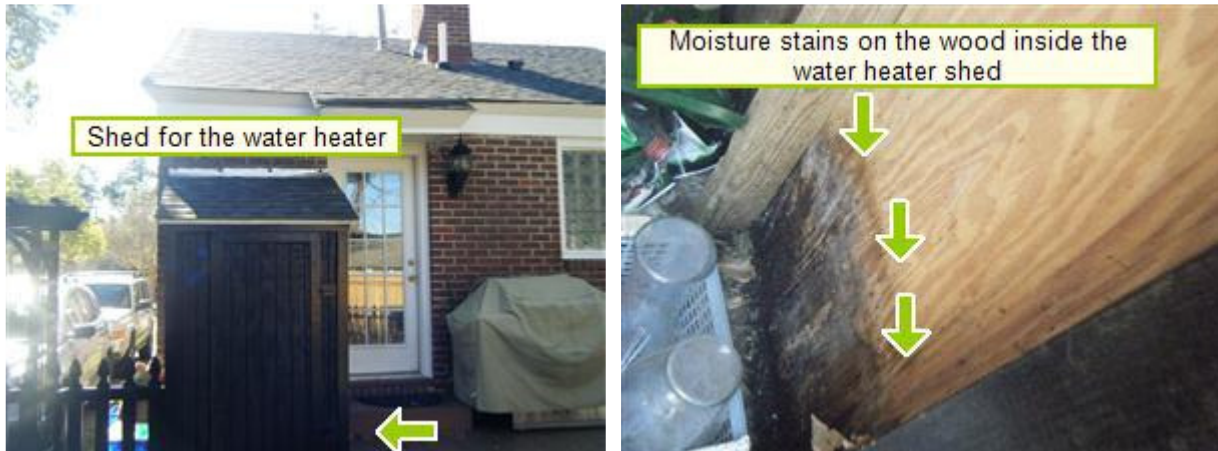
(1) Observed that there are moisture stains and wood rot on the wood inside the water heater shed -- this could be from moisture coming off the deck and dripping onto the shed. Or, it could be from the lack of ventilation under the deck causing condensation on the side of the shed. Recommend having a contractor or handyman repair or replace the wood, as needed, so it is again strong and sturdy.

could be from the lack of ventilation under the deck causing condensation on the side of the shed. Recommend having a contractor or handyman repair or replace the wood, as needed, so it is again strong and sturdy.

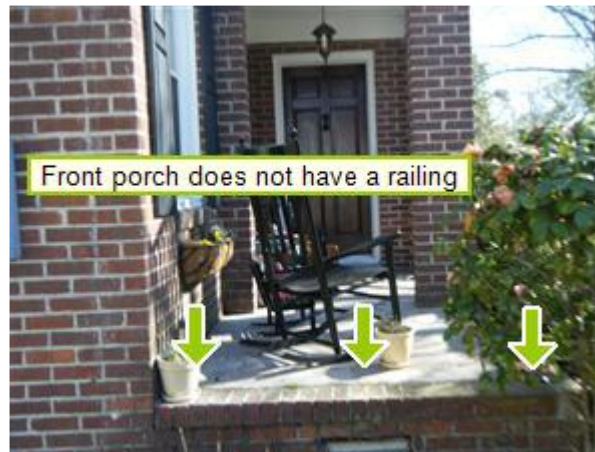
(3) Observed that the front porch and the back deck do not have railings. If you have small children or pets, recommend installing a guard rail, for safety.

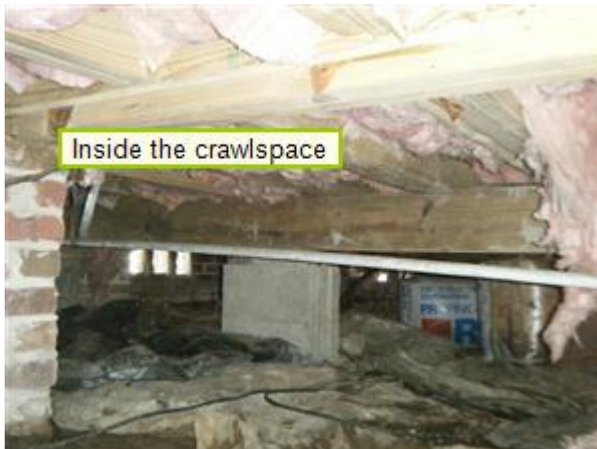
(1) Observed that this home's foundation is a system of brick and block piers and has a brick skirting (wall) which encloses the crawlspace. For your reference, the goal is to keep the crawlspace as dry as possible to protect/preserve the structural integrity of the wood and masonry which comprise the foundation. For your reference, wood which has a moisture content of 20% or more (from direct contact with moisture or from a very humid environment) conditions are ripe for the growth of mold/mildew, the decay fungi which leads to wood rot and termites. When rot sets, the wood loses its structural integrity and the rot can spread if not corrected. In most cases, installation of gutters to divert rain water away from the foundation, a vapor barrier on the ground to reduce moisture vapor along with good ventilation in the crawlspace are usually enough to keep moisture content below 20%.

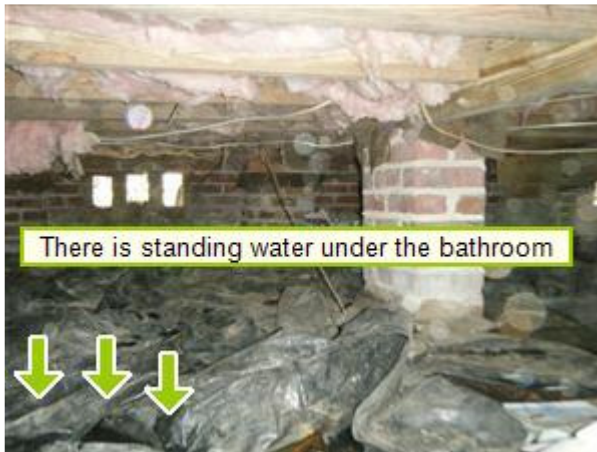
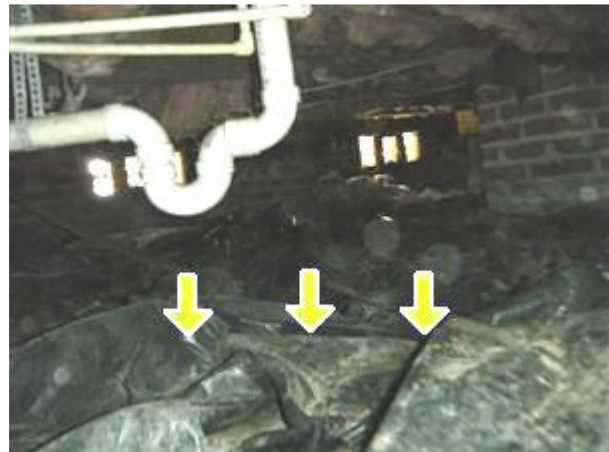
(2) As viewed from inside the crawlspace, observed that there is some standing water in the area under the bathroom. Please note this area is the lowest in the crawlspace and it appears to have come up from the ground and not from the home (i.e. from a leak). To help keep the crawlspace as dry as possible, especially since there is a lot of new wood, recommend having a contractor install a sump pump to reroute excess water to the outside of the home where it can drain away from the foundation.

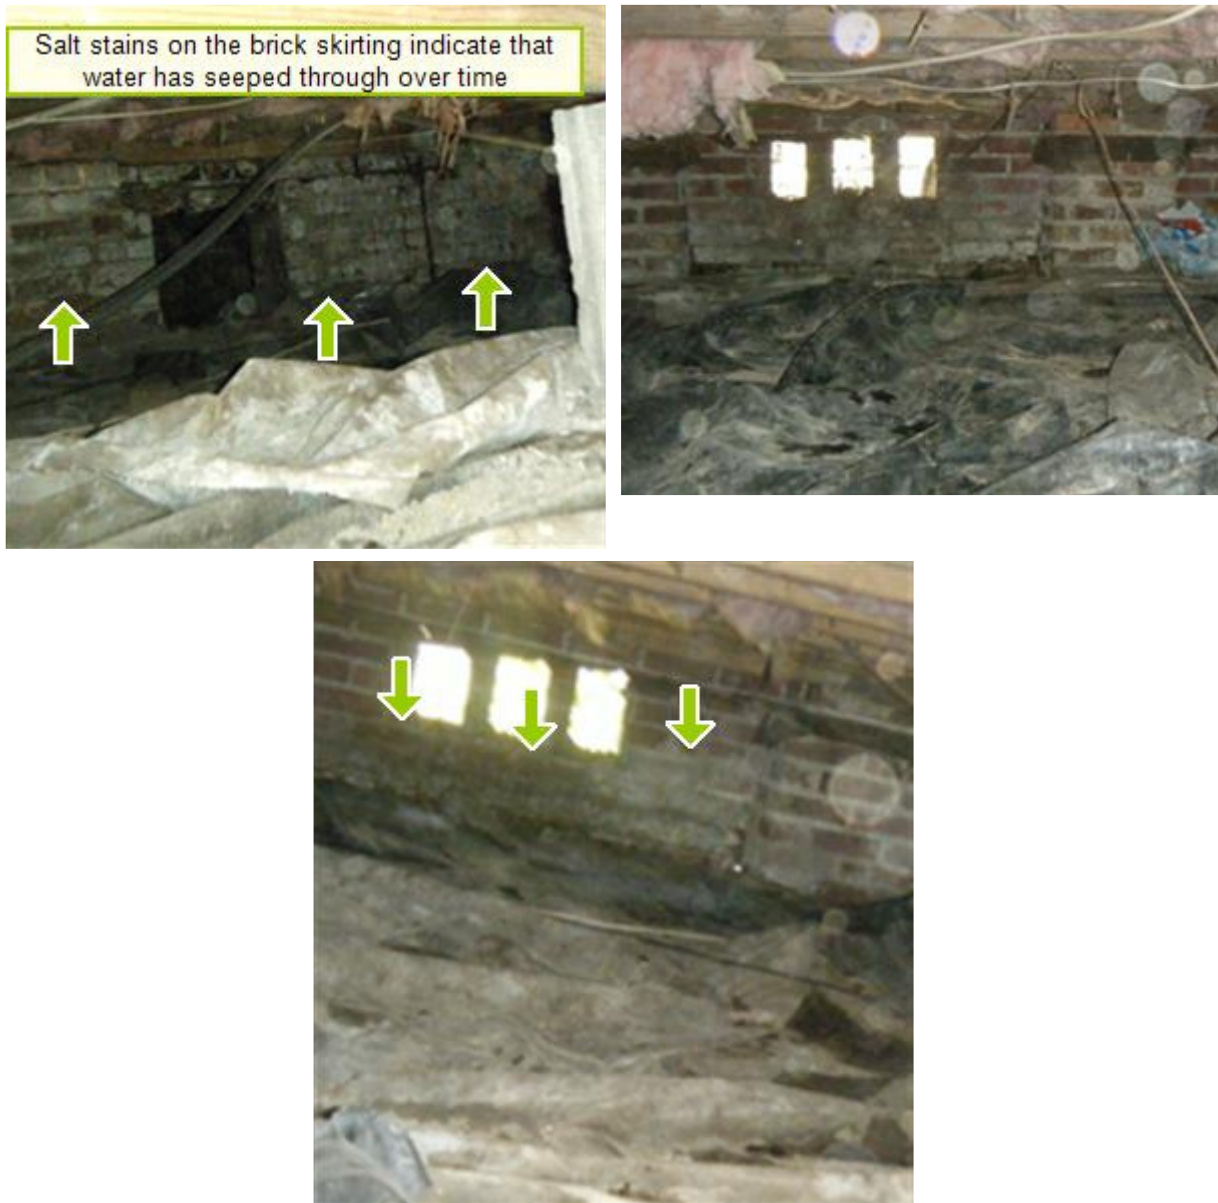
(3) As viewed from inside the crawlspace, observed that there are salt stains on the brick wall/skirting which indicates water has been seeping through this masonry over time -- this is very common. The stains are a whitish, powdery substance (salt stains) called efflorescence and it's left on the bricks or cement blocks after the water has evaporated. This is only of consequence since it contributes to moisture and humidity levels in the crawlspace which can deteriorate wood and masonry structural components over the long-term. Recommend installing gutters (section 1.2) to more effectively carry water away from the home and a sump pump as just discussed.

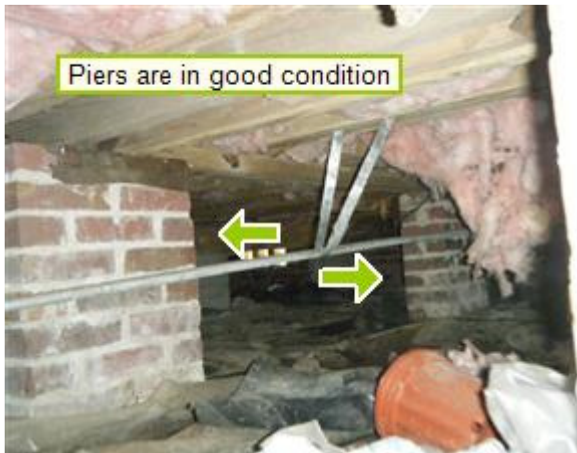
Observed that the piers are in good condition. For your reference, columns/piers are an important structural component of the foundation. Their purpose is to transfer loads from beams down through the footings to the soil.

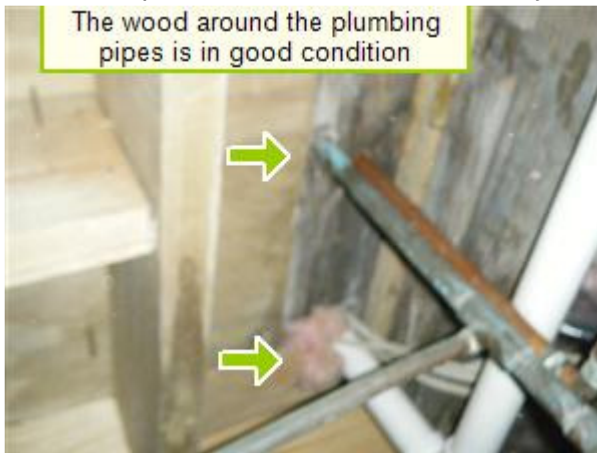
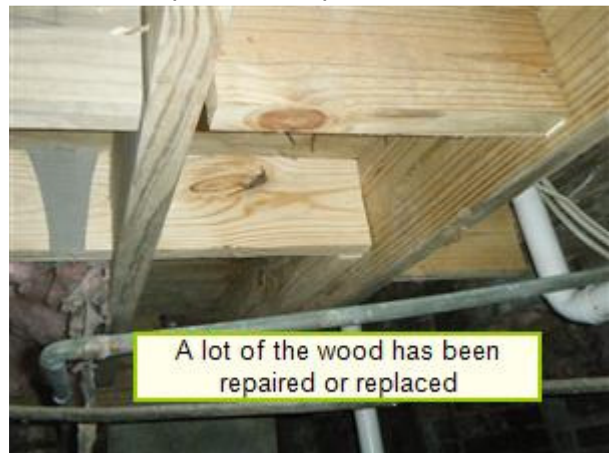
As viewed from inside the crawlspace, the wood (sub-floor and floor joists) around the plumbing pipes is in good condition. Please note the sub-floor around the bathroom has been replaced. Also, most of the floor joists have been repaired or replaced.

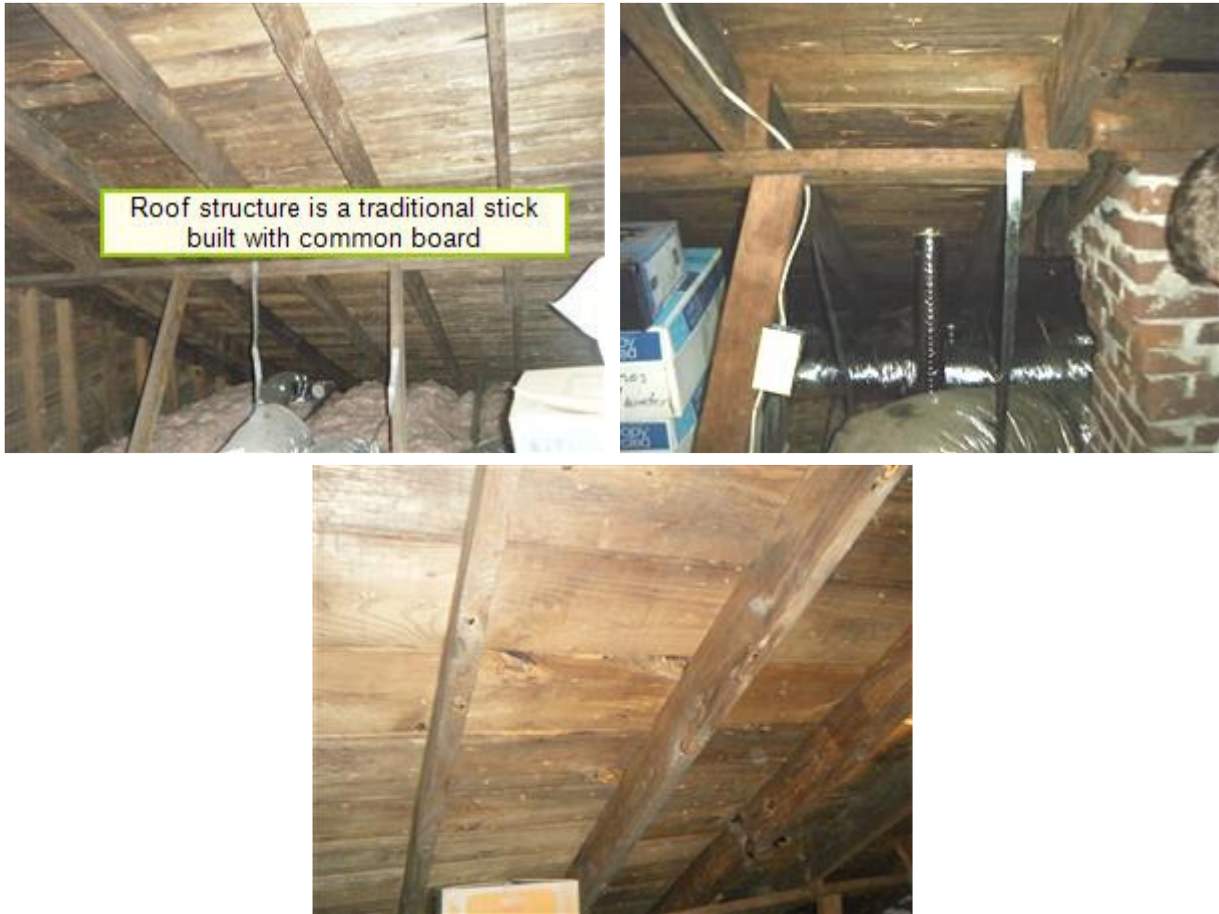
Observed that the roof has a traditional stick built structure with a common board.

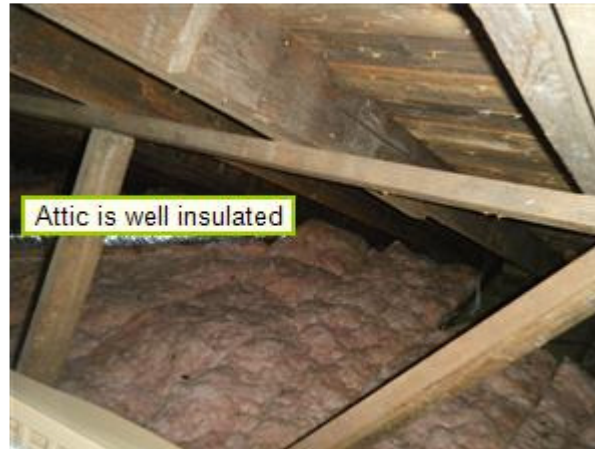
Observed that this home has an amount insulation on the attic floor which equates to R-30 or better. For your reference, the effectiveness of insulation is measured by its R-number which is its ability to resist the flow of heat. The higher the R-number, the greater the resistance to winter heat loss or summer heat gain. Today's standard for insulation in newer homes is R-30 or better.

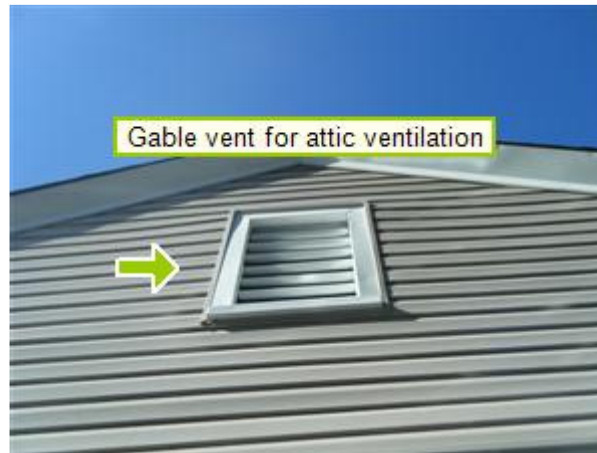
Observed that the attic is ventilated with gable vents. For your reference, ventilation of the home's attic is important to help prevent damage caused by moisture, increase the life of roofing materials, enhance energy efficiency and enhance the comfort level of the living areas in the home. During the summer, excess heat builds up in the attic during the day and results in high energy costs for cooling and may make the rooms below less comfortable. Excessive heat can also shorten the life of some roofing materials. Also, moisture produced within the home may move into the attic if ceiling vapor barriers are not used. If this moisture is not exhausted from the attic, it can condense and cause insulation and construction materials to deteriorate. Therefore, temperature and moisture control are the major reasons for providing attic ventilation.

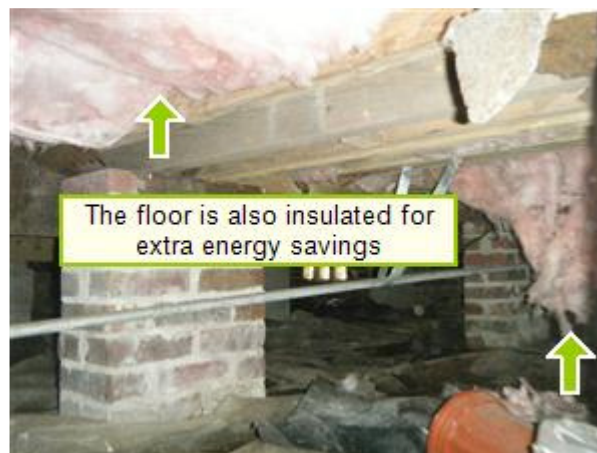
Observed that the floor system is insulated -- a positive. Up to 25% of energy can be lost through a non-insulated floor.

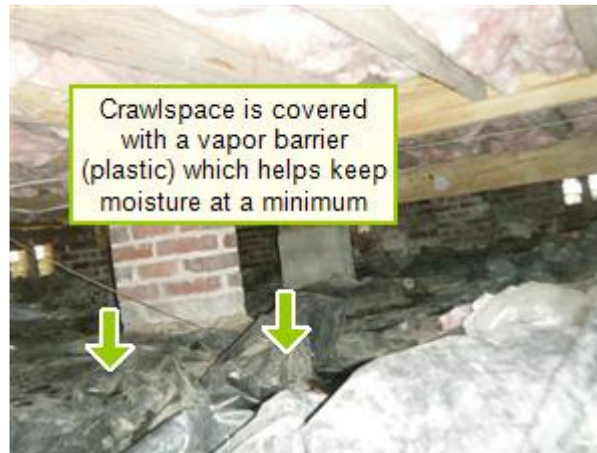
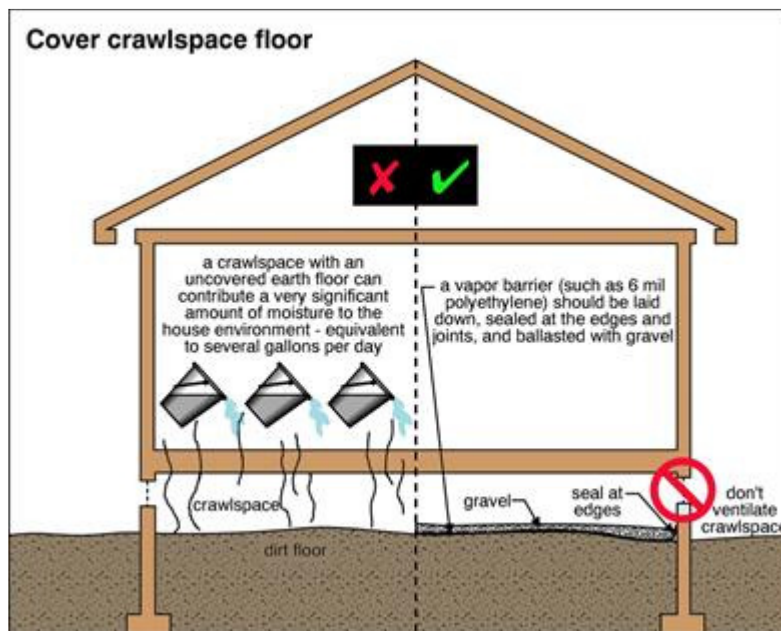
Observed that this home has a vapor barrier (plastic) on the ground in the crawlspace and it is in good condition. For your reference, a vapor barrier helps to keep moisture and dampness in the crawlspace at a minimum to preserve the condition of the wood and masonry components that comprise the foundation. Additionally, it helps prevent the house from smelling musty. When there is excess moisture in the crawlspace, conditions are ripe for the growth of mold and mildew, the decay fungi which leads to wood rot and wood-eating insects.

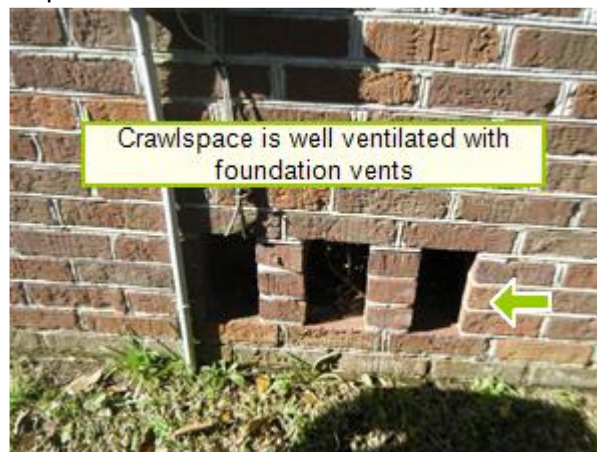
(1) Observed that the crawlspace is well ventilated with foundation vents -- this helps keep the crawlspace as dry as possible to protect the structural integrity of the wood and masonry components which comprise the foundation.

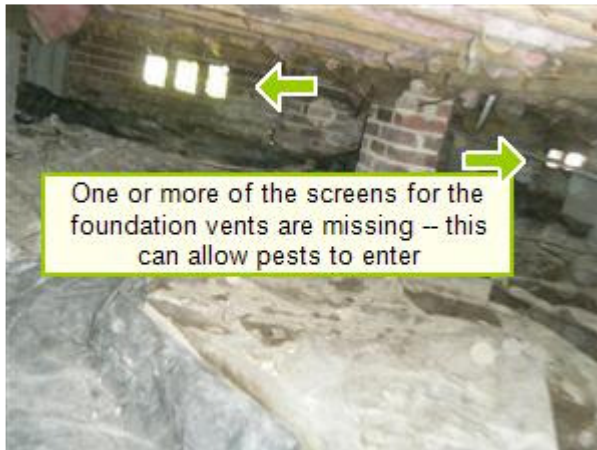
(2) Observed that one or more of the screens for the foundations vents are either damaged

or are missing -- this can allow pests to enter under the home. Recommend having a handyman install screens for the foundation vents, where needed, to help keep pests out.

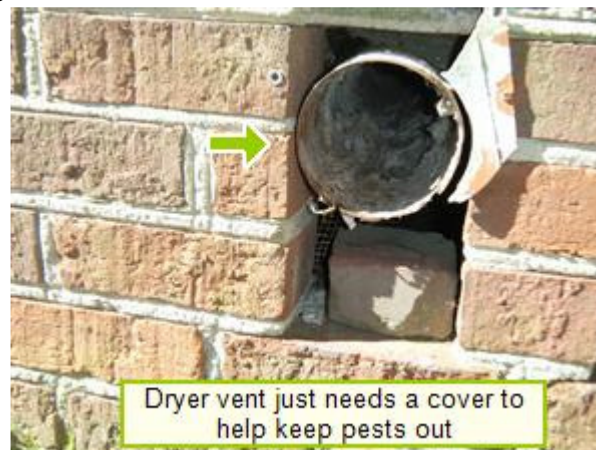
Observed that the vent for the dryer is missing its cover on the exterior of the home. Recommend having a handyman install a cover to prevent pests from entering the home through this opening.

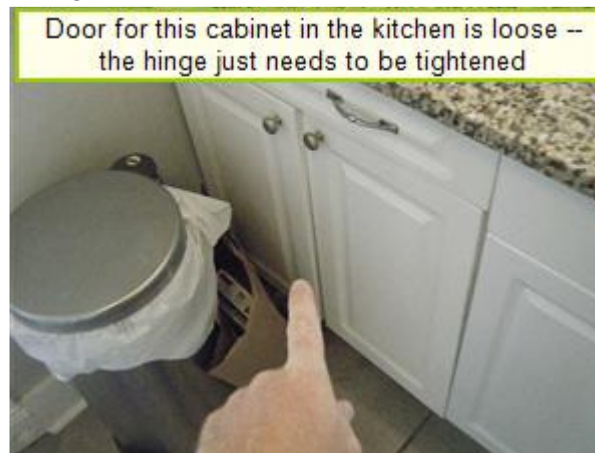
(1) Observed that the door for one of the kitchen cabinets is loose. Recommend having a handyman tighten the hinge for this door.

(1) Observed that the door for one of the kitchen cabinets is loose. Recommend having a handyman tighten the hinge for this door.

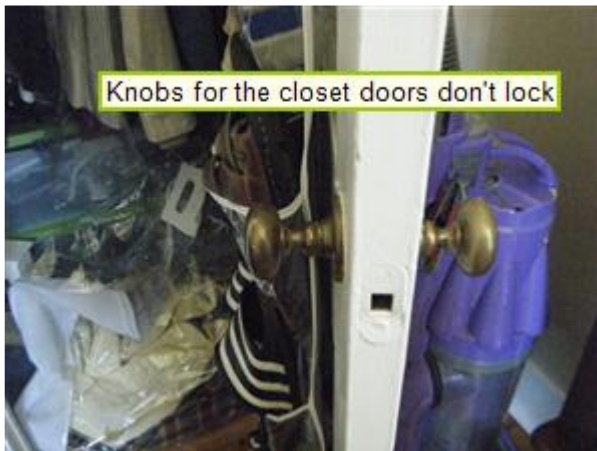
Observed that the door knobs/handles for the closet doors do not lock. As desired, a handyman can replace the door knobs with ones that lock.

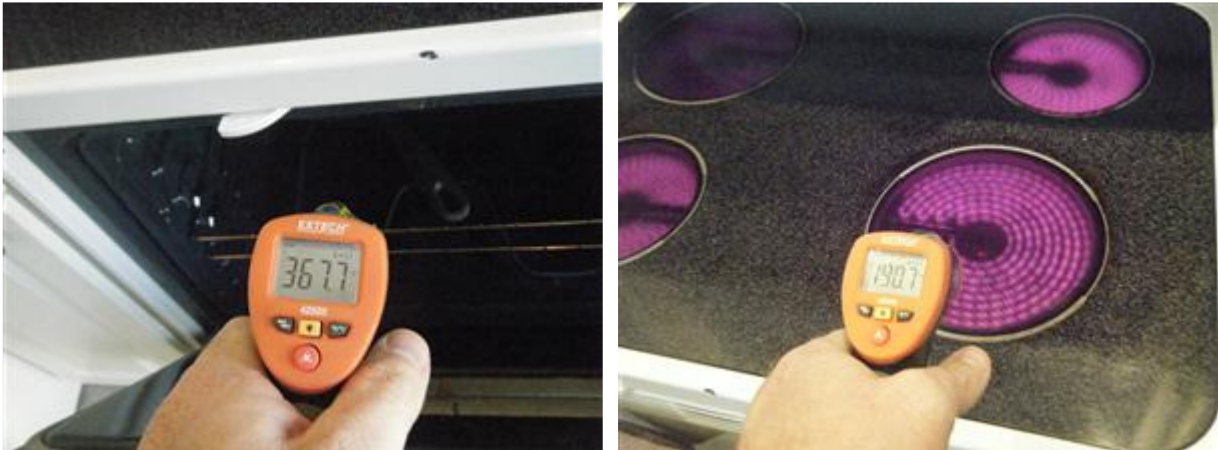
Observed that the oven and cooktop appear to be working well -- they were tested with a infrared red thermometer to ensure they are heating as they should. Please note I did not test

for maximum temperature. For your reference, the average electric range will last about 17 years (gas ranges last about 19 years) and the cooktop will last between 13 and 20 years.

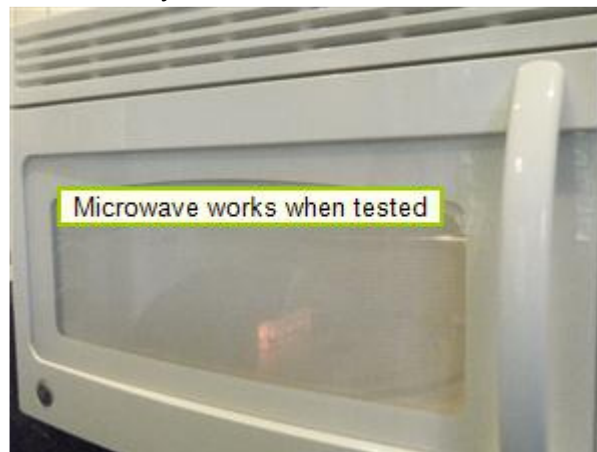
Observed that the microwave appears to be working well -- it was tested with a microwave tester to ensure it is operating properly and that there are no door leaks. For your reference, the average microwave lasts 10 years.

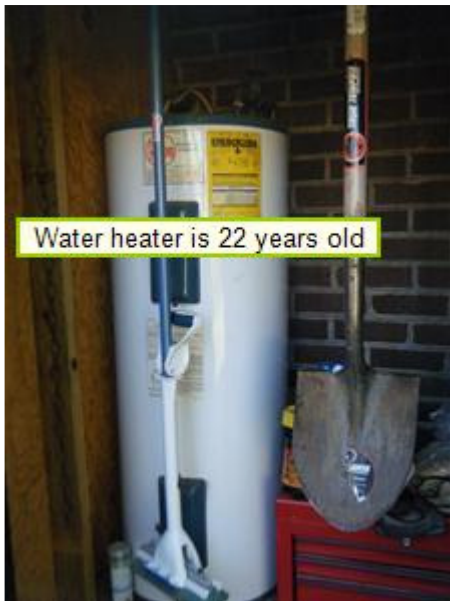
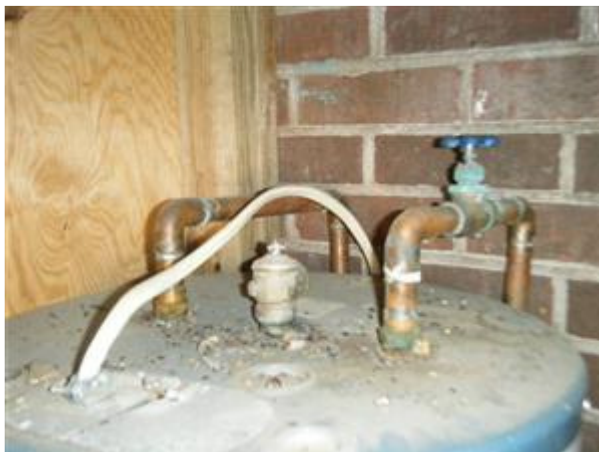
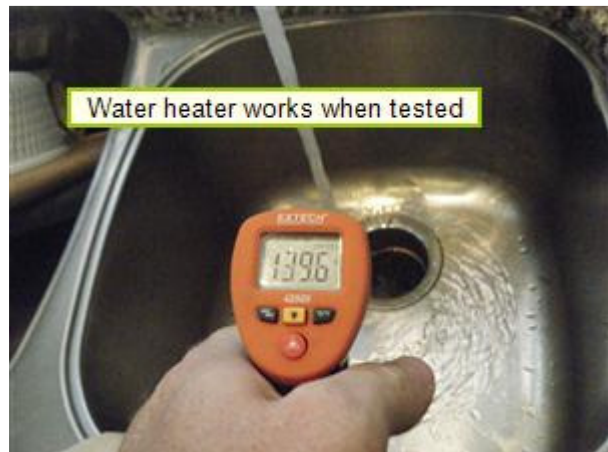
(1) Observed that the electric hot water heater is 22 years old. Please note the water heater works when tested. For your reference, the average hot water heater lasts about 12 years and sometimes longer. Due to its extensive age, recommend monitoring the hot water heater for possible problems or leaks and plan to replace this unit, when needed.

(1) Observed that the electric hot water heater is 22 years old. Please note the water heater works when tested. For your reference, the average hot water heater lasts about 12 years and sometimes longer. Due to its extensive age, recommend monitoring the hot water heater for possible problems or leaks and plan to replace this unit, when needed.

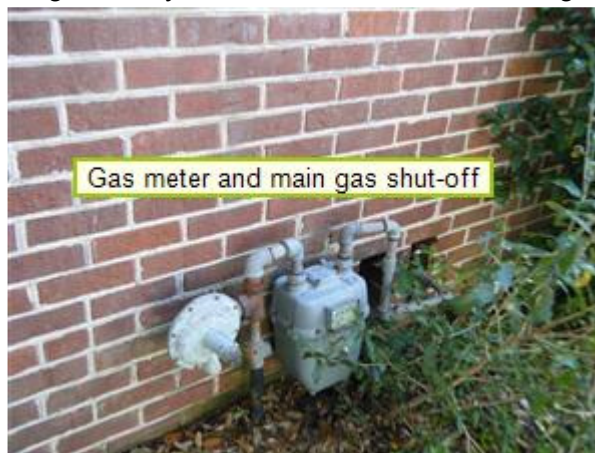
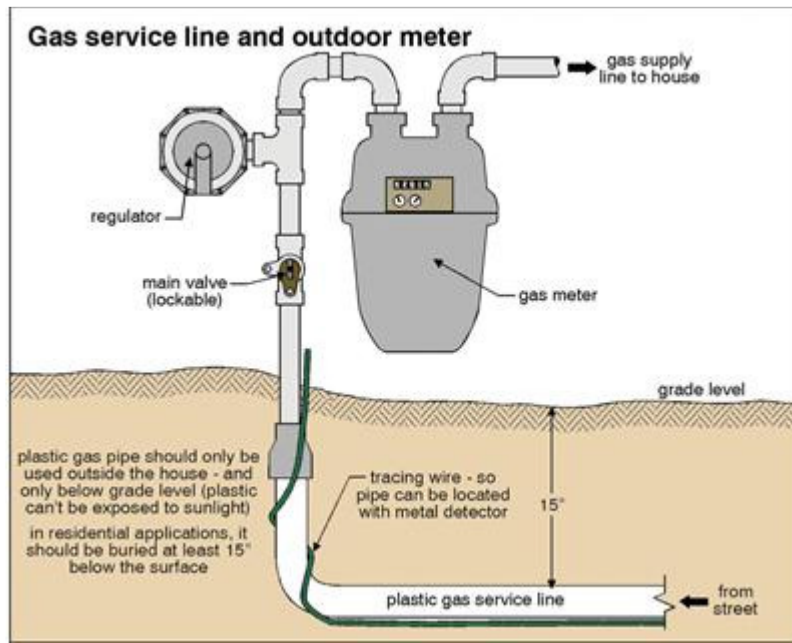
(1) The main fuel/gas shut-off is located at the gas meter outside. In the event that repairs need to be made to the gas line, you'll need to know where the gas shut-off is located.

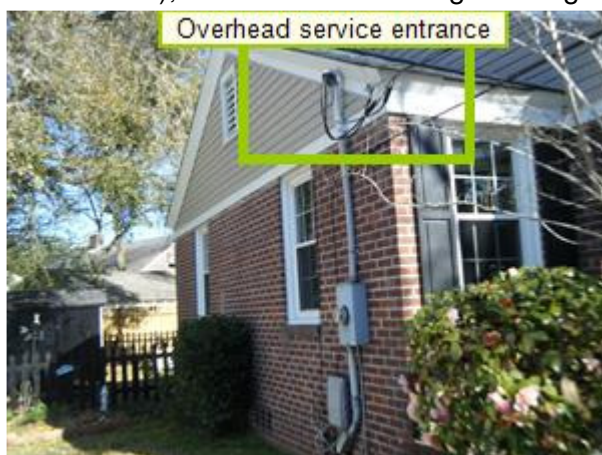
Observed that the overhead service entrance conductor (where the power enters the home from the street), electrical meter and grounding rod are in good working condition.

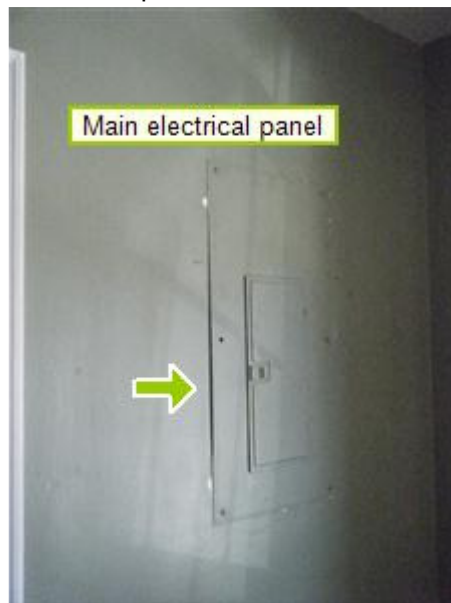
The main electrical panel is located in the dining room.

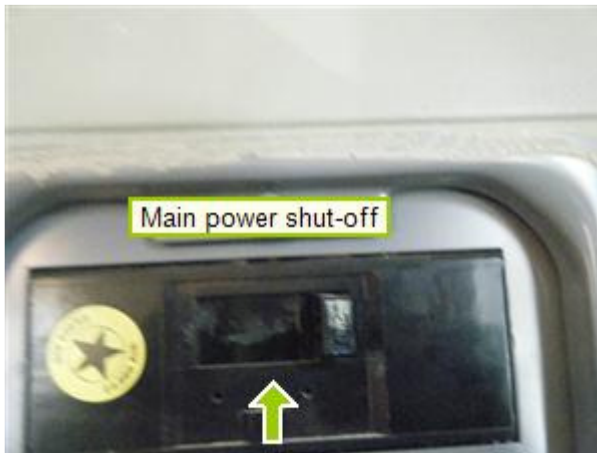
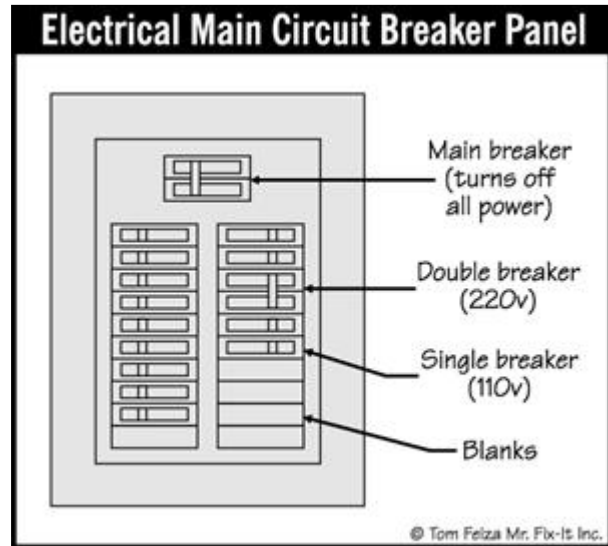
Observed the main electrical disconnect (also called a main breaker) is on located on the main electrical panel. It is helpful to know where the main breaker is in case you need to turn off the power for the whole home.

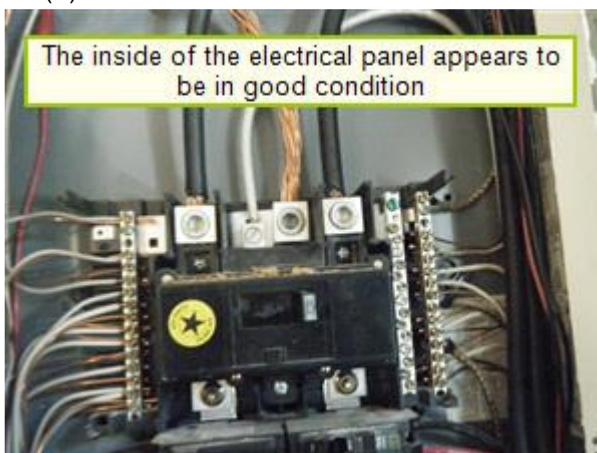
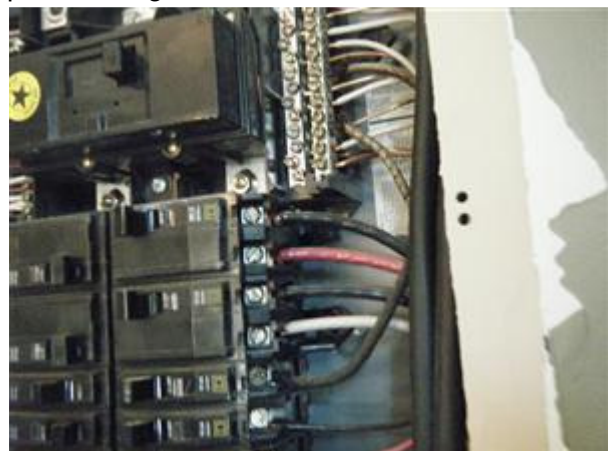
(1) Observed that the inside of the electrical panel is in good condition.

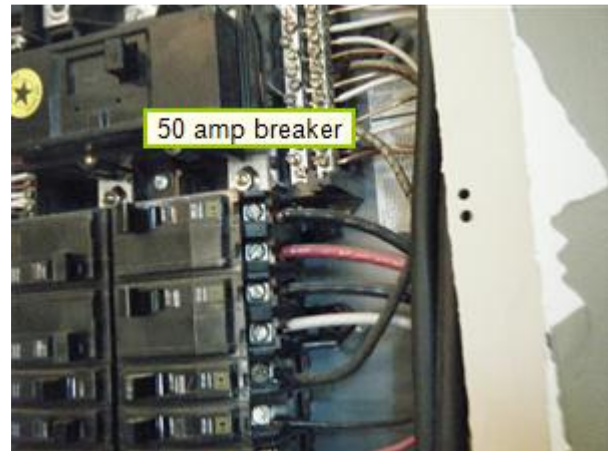
Observed that the outdoor a/c compressor calls for a maximum circuit breaker of 25 amp as indicated on it's label. However, the circuit breaker for the compressor in the electrical panel is 50 amp -- this means that the a/c unit could be damaged before the breaker would trip. For your reference, the breaker for the a/c compressor must be the right size to protect the air conditioner and its wiring from damage or fire. Recommend having an electrician change the breaker in the electrical panel so that it is 25 amp, for safety.

Observed that the outdoor a/c compressor calls for a maximum circuit breaker of 25 amp as indicated on its label. However, the circuit breaker for the compressor in the electrical panel is 50 amp -- this means that the a/c unit could be damaged before the breaker would trip. For your reference, the breaker for the a/c compressor must be the right size to protect the air conditioner and its wiring from damage or fire. Recommend having an electrician change the breaker in the electrical panel so that it is 25 amp, for safety.

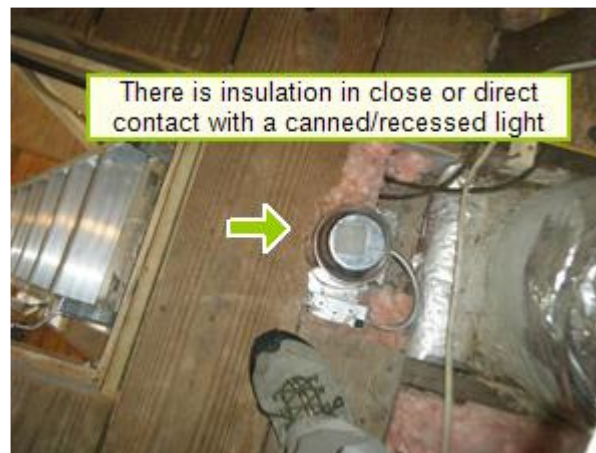
Observed that there are one or more canned/recessed lights in the attic which have insulation in close or direct contact with them which is a fire hazard. Please note that these lights can get very hot. Recommend having a handyman move the insulation away from the lights so there is sufficient clearance all the way around and on top of these fixtures, where needed, for safety.

Observed that there are one or more canned/recessed lights in the attic which have insulation in close or direct contact with them which is a fire hazard. Please note that these lights can get very hot. Recommend having a handyman move the insulation away from the lights so there is sufficient clearance all the way around and on top of these fixtures, where needed, for safety.

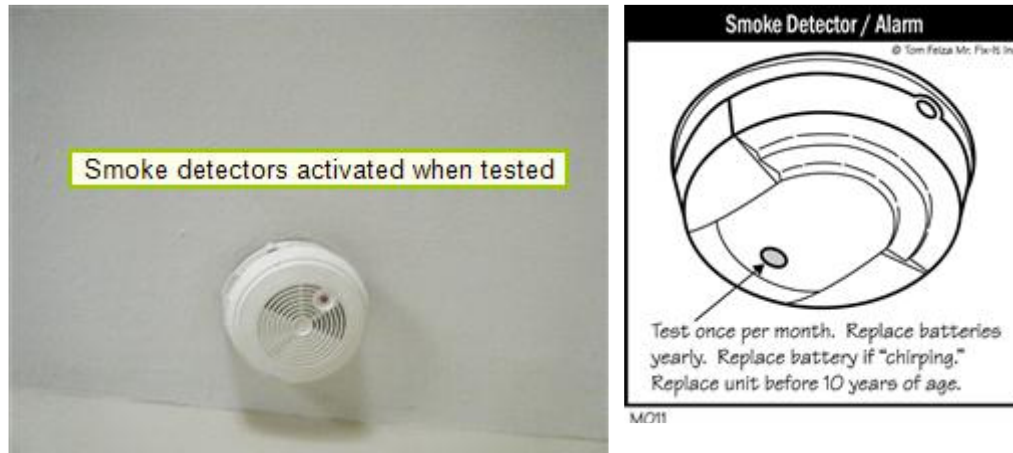
Observed that this home has smoke detectors which activated when tested. Please note there should be one smoke detector in each sleeping area/bedroom, another smoke detector in the hallway outside the sleeping area and at least one smoke detector on each level of the home. Also, test the detectors every 30 days by pushing the test button. *If you don't know how old your smoke detector is, or if it is 10 years old or more, suggest replacing it as soon as possible to ensure that it works when it needs to, for safety.*

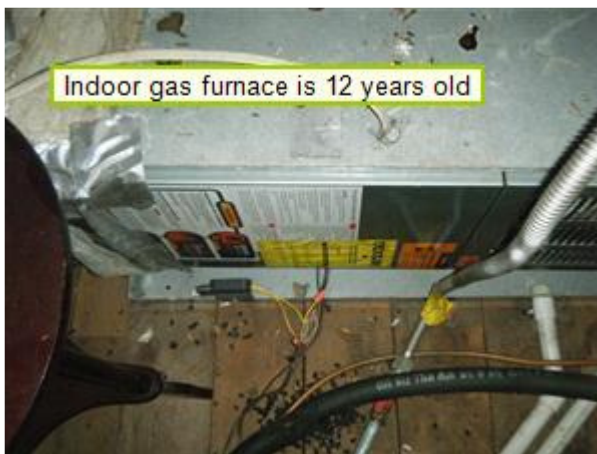
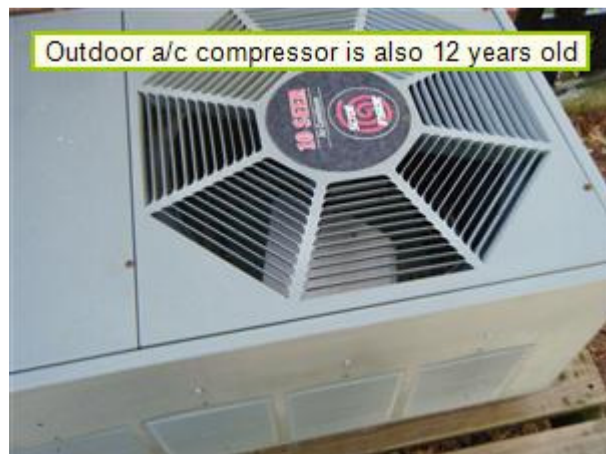
(1) Observed that this home has a gas furnace and an outdoor a/c compressor which work together to heat and cool the home. Both pieces of equipment are 12 years old. For your reference, outdoor a/c compressors generally last up to 15 years and furnaces up to 20 years and both often longer with good maintenance. Due to age, recommend monitoring the outdoor compressor for possible problems and plan to replace it in the next few years or so, when needed.

(1) Observed that this home has a gas furnace and an outdoor a/c compressor which work together to heat and cool the home. Both pieces of equipment are 12 years old. For your reference, outdoor a/c compressors generally last up to 15 years and furnaces up to 20 years and both often longer with good maintenance. Due to age, recommend monitoring the outdoor compressor for possible problems and plan to replace it in the next few years or so, when needed.

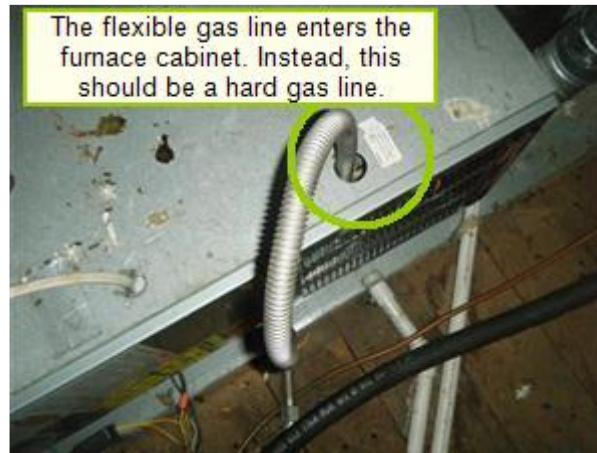
(2) Observed that there is a flexible gas line entering the metal cabinet for the furnace. Instead, there should be a hard pipe which comes out of the cabinet and attaches to the flexible line to ensure the gas line is properly secured. Recommend having an HVAC repairman make the needed repairs.

(2) Observed that there is a flexible gas line entering the metal cabinet for the furnace. Instead, there should be a hard pipe which comes out of the cabinet and attaches to the flexible line to ensure the gas line is properly secured. Recommend having an HVAC

repairman make the needed repairs.

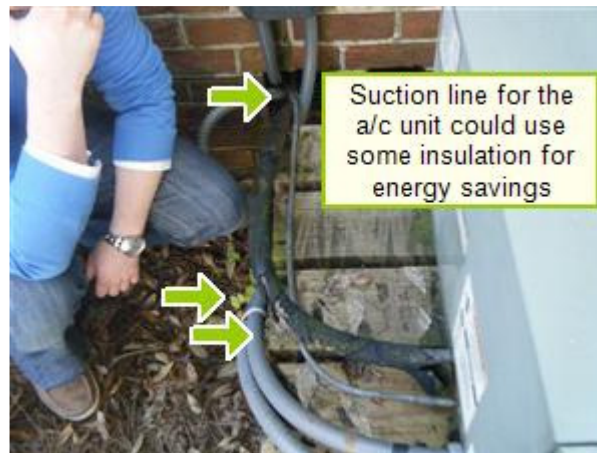
(3) At the outside compressor unit for the HVAC, the suction line is not completely insulated with a foam sleeve -- on this unit, part of the foam sleeve is missing which can cause hinder the home's cooling ability and produce condensation. Recommend having an HVAC repairman insulate the suction line where needed.
