Home Inspection Report

Property address: 321 Elm St.
Charleston SC 29414

Inspected by: Stephen Houmar
South Carolina License #2046
Solid Ground Home Inspections, LLC
843.330.2860
Professional Member:
-American Society of Home Inspectors (ASHI)

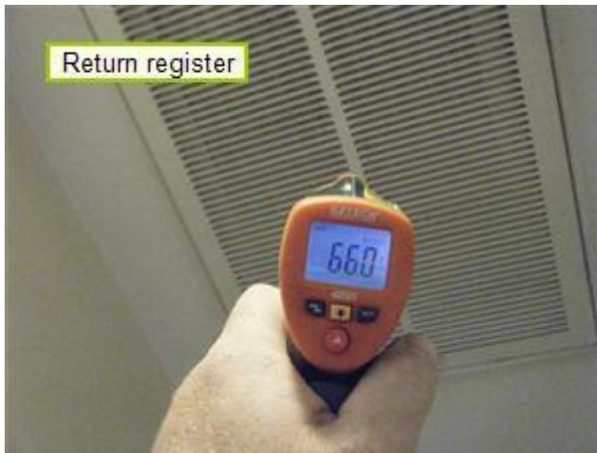
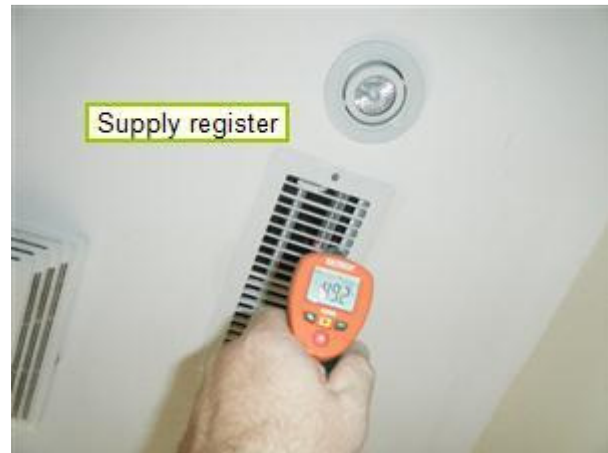
(1) When tested, it appears that the air conditioning is working well. For your reference, there should be at least a 14 degree difference between the air at the return air register and where the cooled air enters the home from the supply air register to indicate normal functioning. In this case, there was a 17 degrees difference.

Please note the heat was not tested since the outside temperature was above 65 degrees. It is likely that the heat is working as it should.

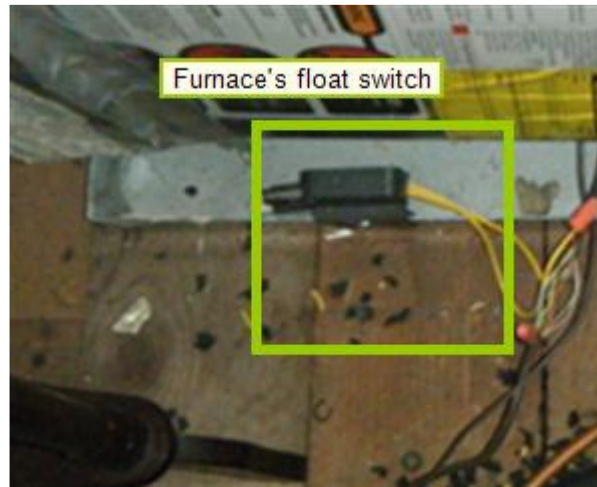
Please note the air handler has a 'float switch' which will turn off the outdoor compressor when the condensation pan (for the air handler) fills up to prevent the water from spilling over onto the floor below.

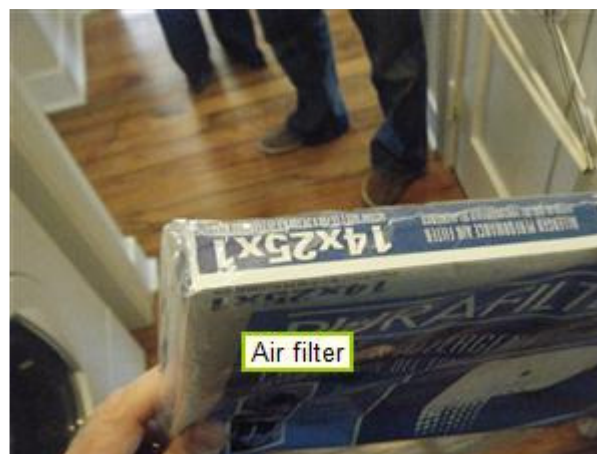
Observed that the size of the air filter is 14 x 25. Recommend using an inexpensive air filter and changing it frequently - ideally once a month. An easy way to remember to change the air filter is to change it when you pay the power bill each month. For your reference, the purpose of the air filter is to keep your furnace/air handler clean. A dirty, clogged filter blocks air flow and reduces the system's efficiency. If dirty air filters aren't changed regularly, the system can produce excess condensation which you may then see as a moisture stain on your ceiling. Please note the higher end filters make it more difficult for your furnace/air handler to draw and push air throughout your home, putting strain on your furnace/air handler and your energy bills.
